# Status of the JWST Science Instrument Payload

9 August 2015

# The Integrated Science Instrument Module (ISIM) is the science instrument payload of the JWST

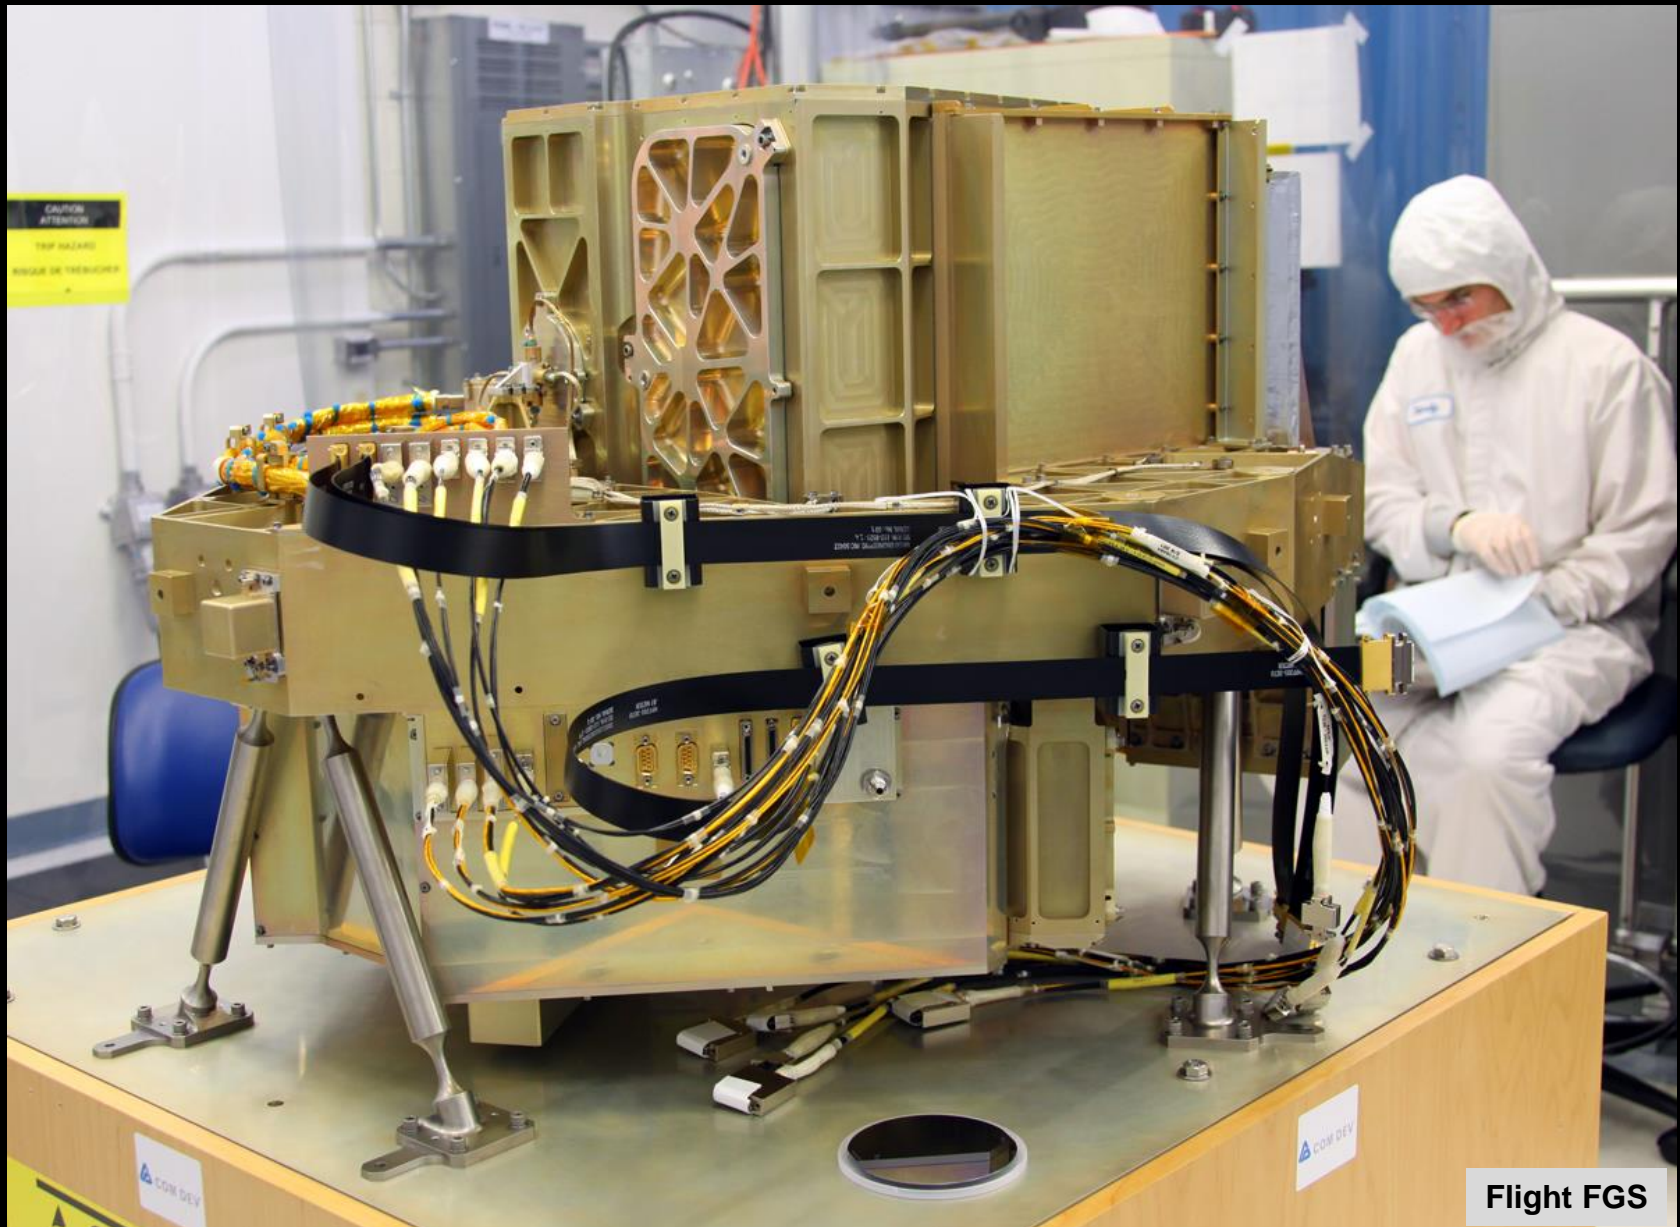
**Flight FGS**

**FGS can sense pointing to 1 millionth degree precision**

**NIRISS enables moderate contrast imagery at an inner working angle of  $0.5\lambda/D$**

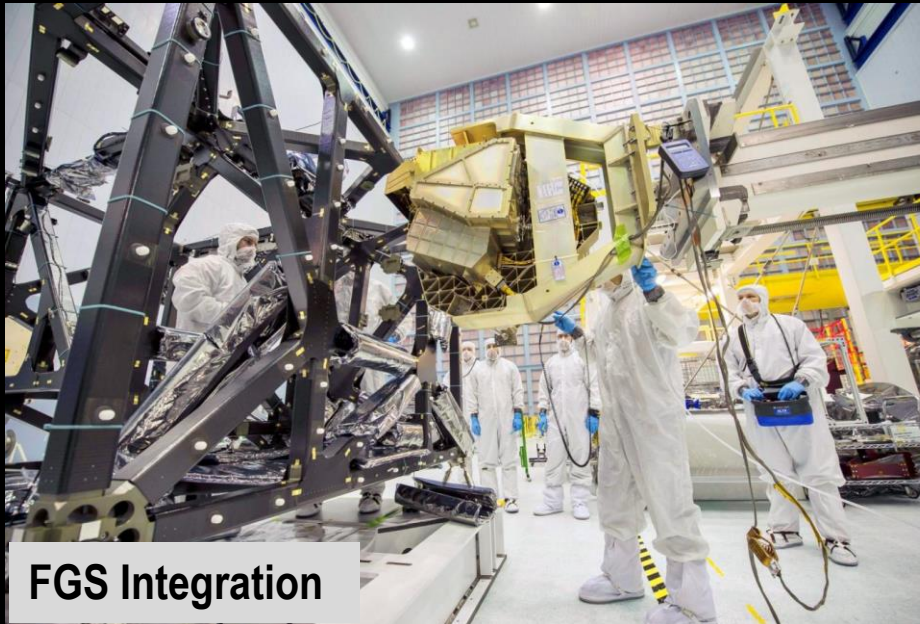
**FGS Integration**

# Sensor systems being integrated into science instrument module

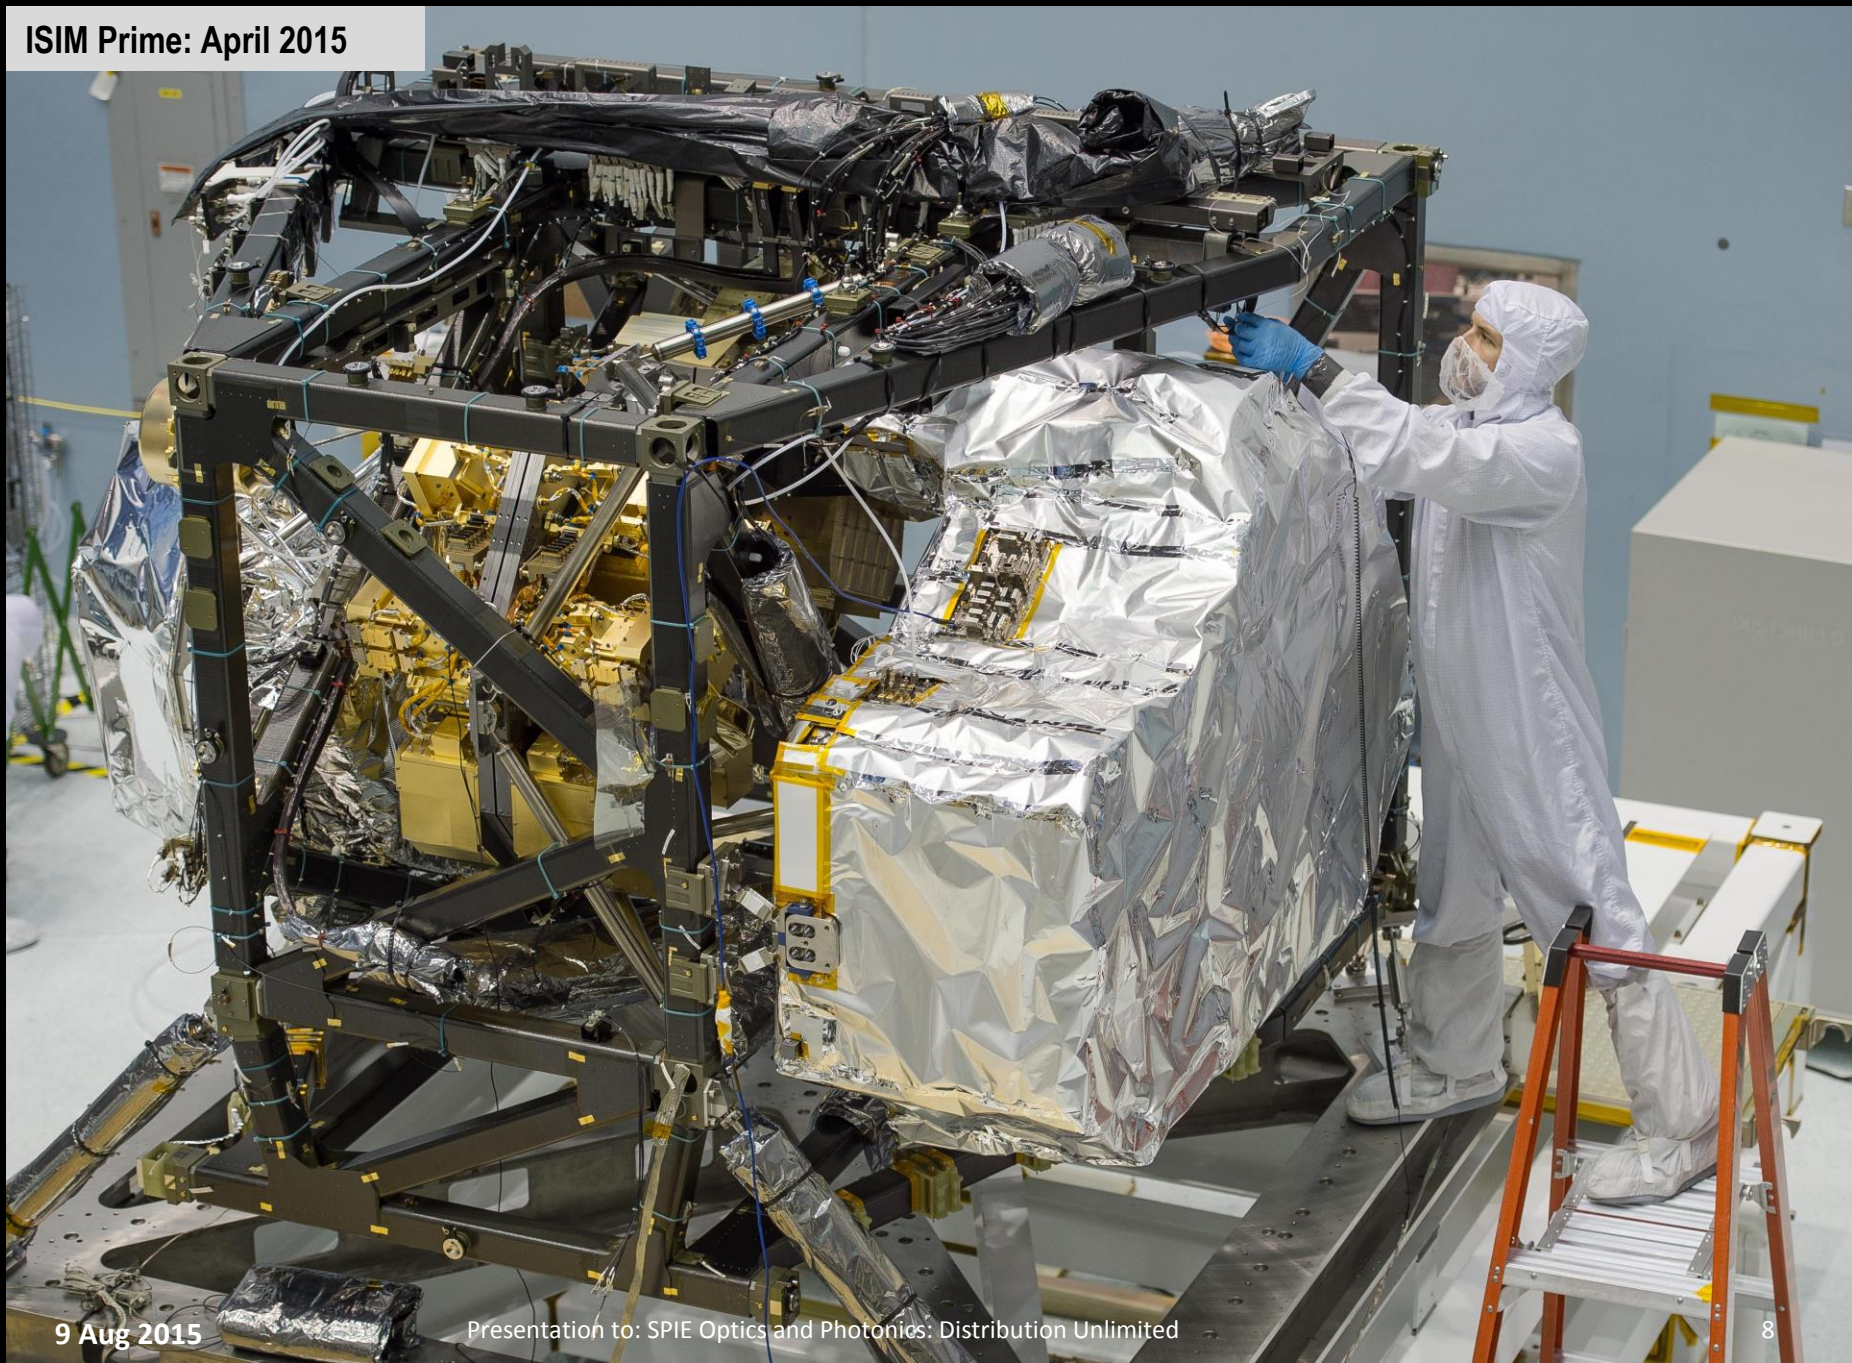
ISIM Prime: April 2015

# Instrument module at 100% integration in preparation for CV-3 test

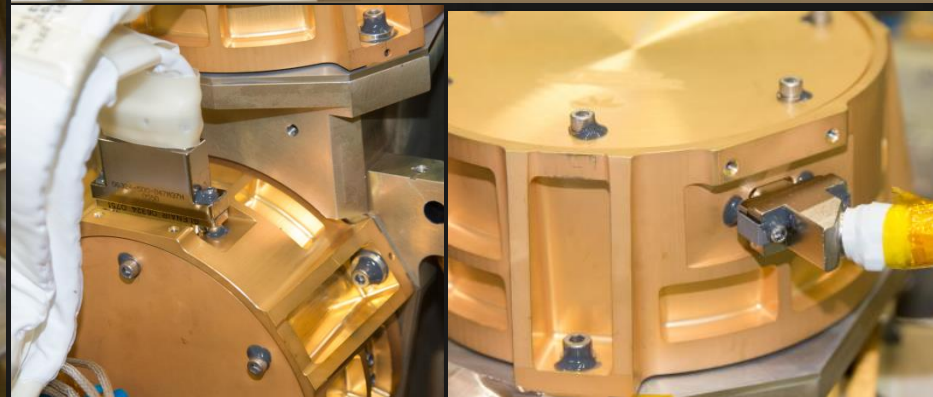
# New FPAs were installed into Guider 1 and 2

- Replaced 3 detector FPAs due to the detector degradation issue
- Replaced 2 gearmotors on the Dual Wheel
- Replaced the GR700 grism on the Dual Wheel
- Replaced the GR150 grism that had a substrate failure during CV2
- Inspected the second GR150 grism for delamination: No delamination observed

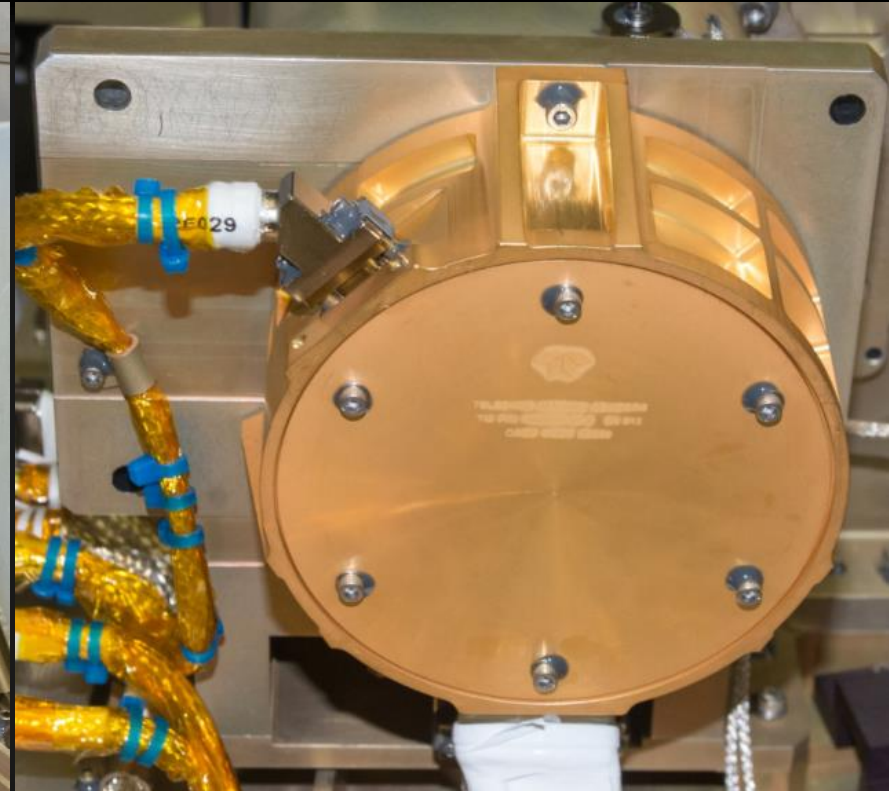
# A new FPA was installed into NIRISS

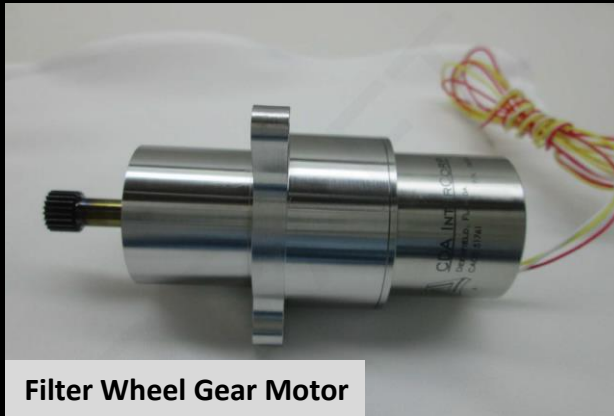
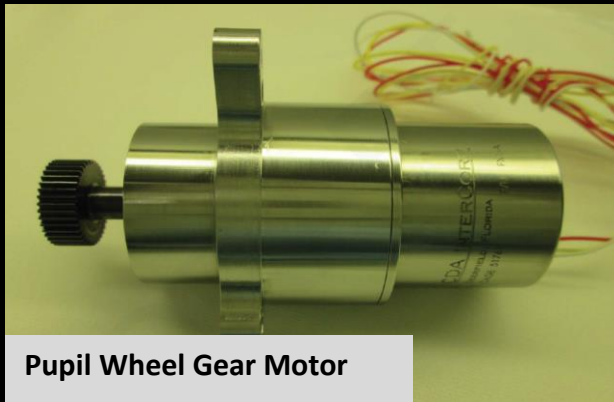
# FGS gear motors were redesigned to improve operational lifetime

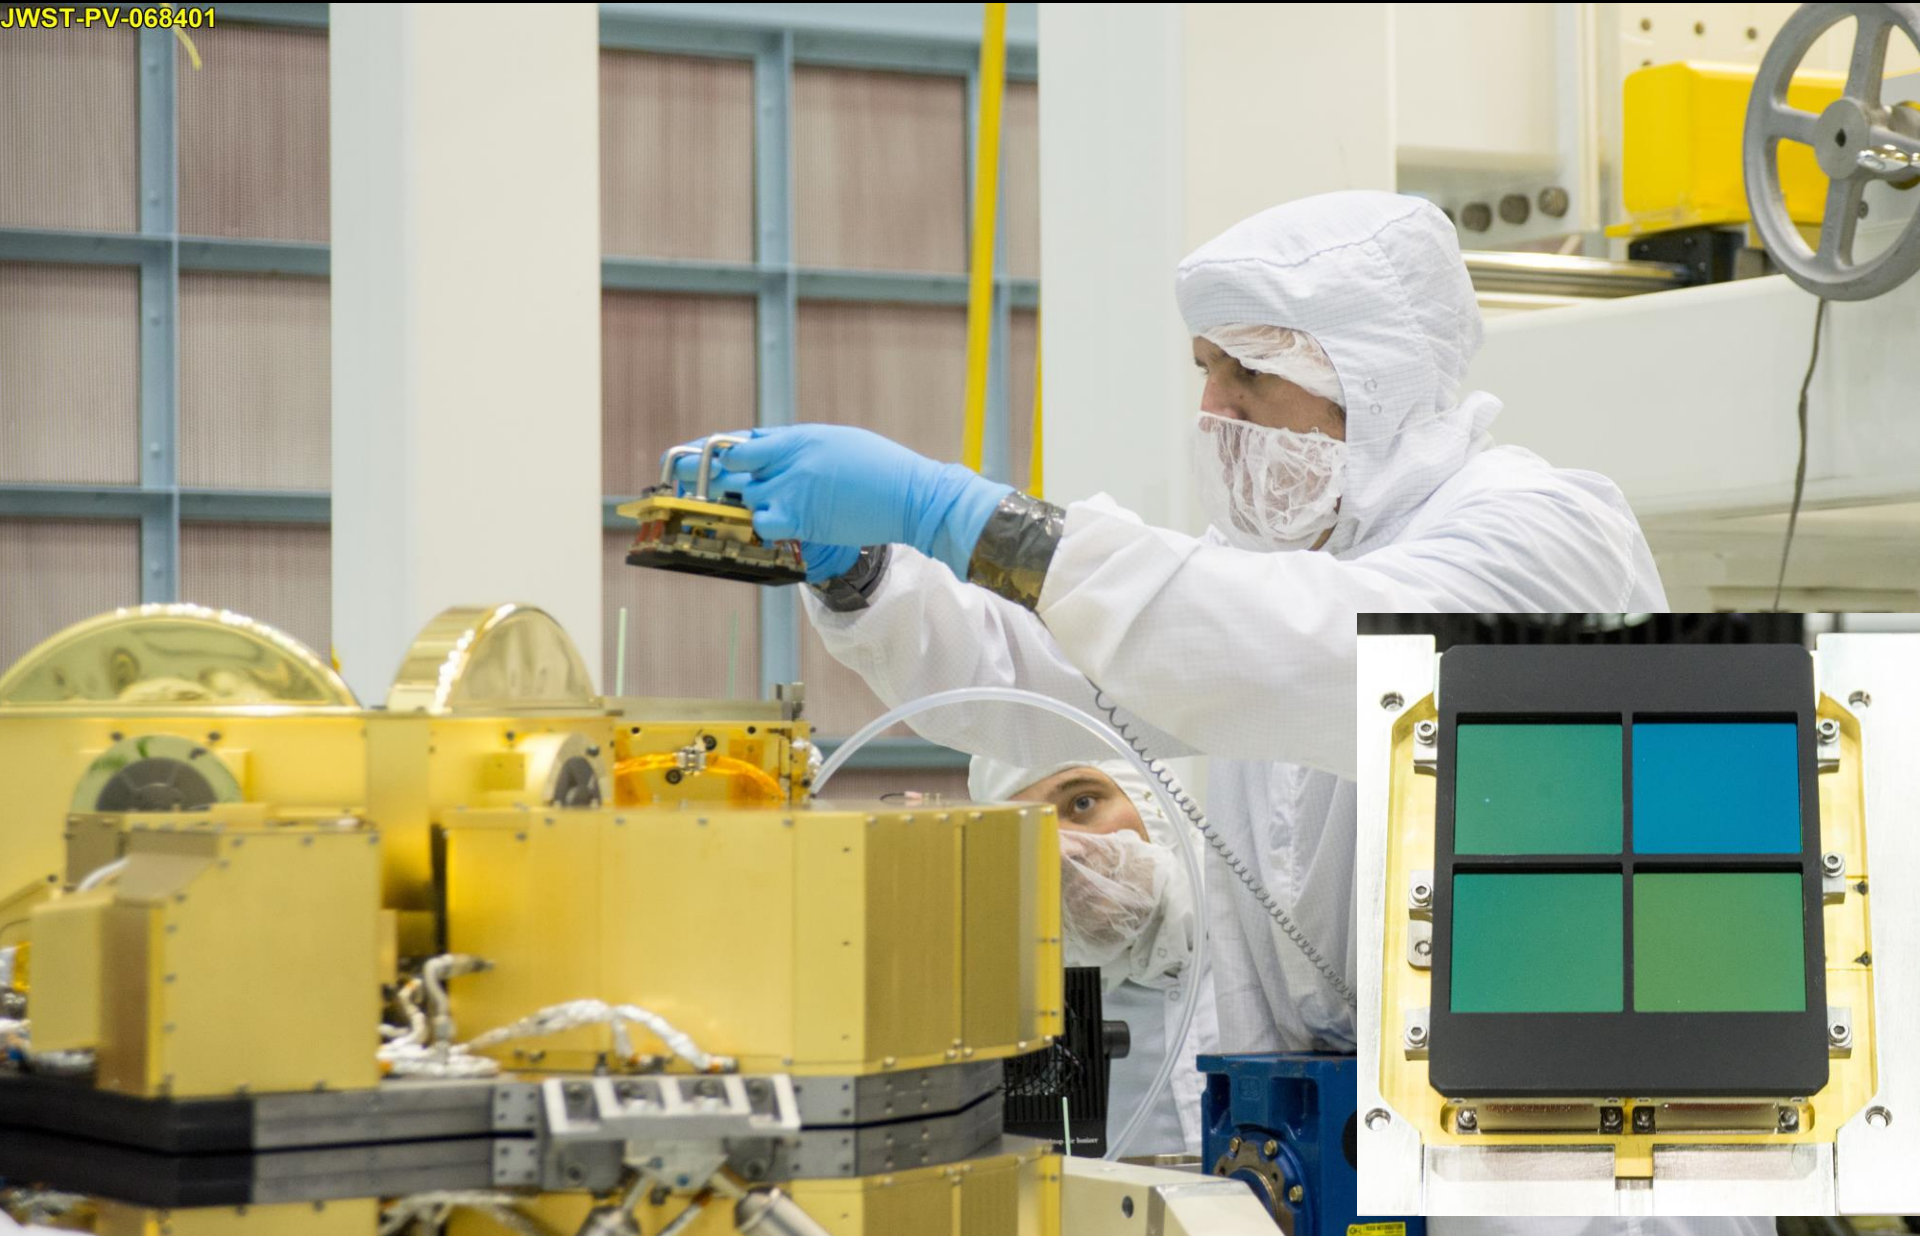
JWST-PV-068401

# Replacing FPAs on NIRCcam

- Debris was removed from a LW-A FPA connector which fixed a ground isolation short that was discovered prior to CV-2.
- Replaced 3 SCAs and on the SW-A FPA
  - The SW-A was successfully vibed at unit level prior to reintegration with the OA
- Replaced light shields on all FPAs
- Mod-A alignment cube was tested for stability to retire a flight safety concern
